Research Report  
KTC-99-61

**EVALUATION OF THE ADAPTIR SYSTEM  
FOR WORK ZONE TRAFFIC CONTROL**

Kentucky Transportation Center  
College of Engineering  
University of Kentucky  
Lexington, Kentucky

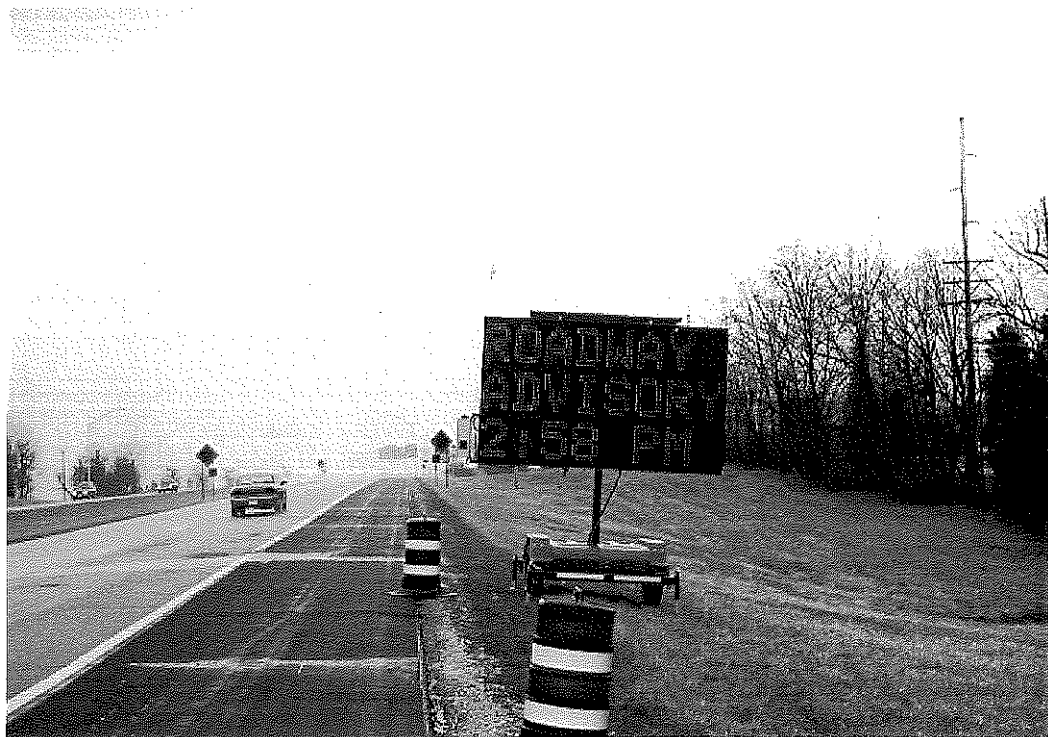
Figure 2. Message Showing Current Time.

Average speeds were calculated at each VMS and the arrow display at set intervals (every two minutes westbound and every three minutes eastbound). When the average speed between two adjacent radar locations was reduced by 10 mph or more, a message was displayed on the VMS upstream from the location at which the radar found the reduced speed. The speed warning consisted of a sequence of the following two messages.

ROADWAY		REDUCE
ADVISORY		SPEED TO
XX AM OR PM	followed by	XX MPH

Photographs showing these messages are shown in Figures 2 and 3. The message was updated every two minutes for the ADAPTIR system used in the westbound direction and every three minutes for the contractor's system in the eastbound direction. The "time stamp" gave a new time so motorists would realize the information was current. The speed was given in five mph increments with the speed rounded to the next lowest five mph interval from the average. If traffic was stopped at one location giving a zero speed, the upstream VMS gave a speed of five mph.

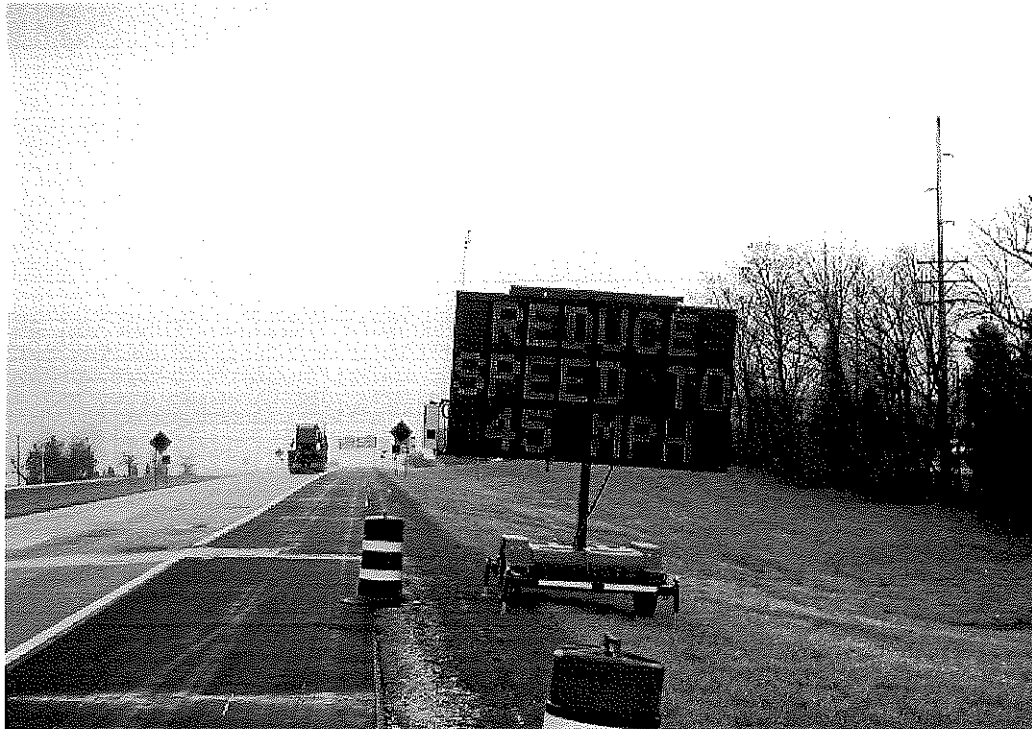
Figure 3. Speed Advisory Message.

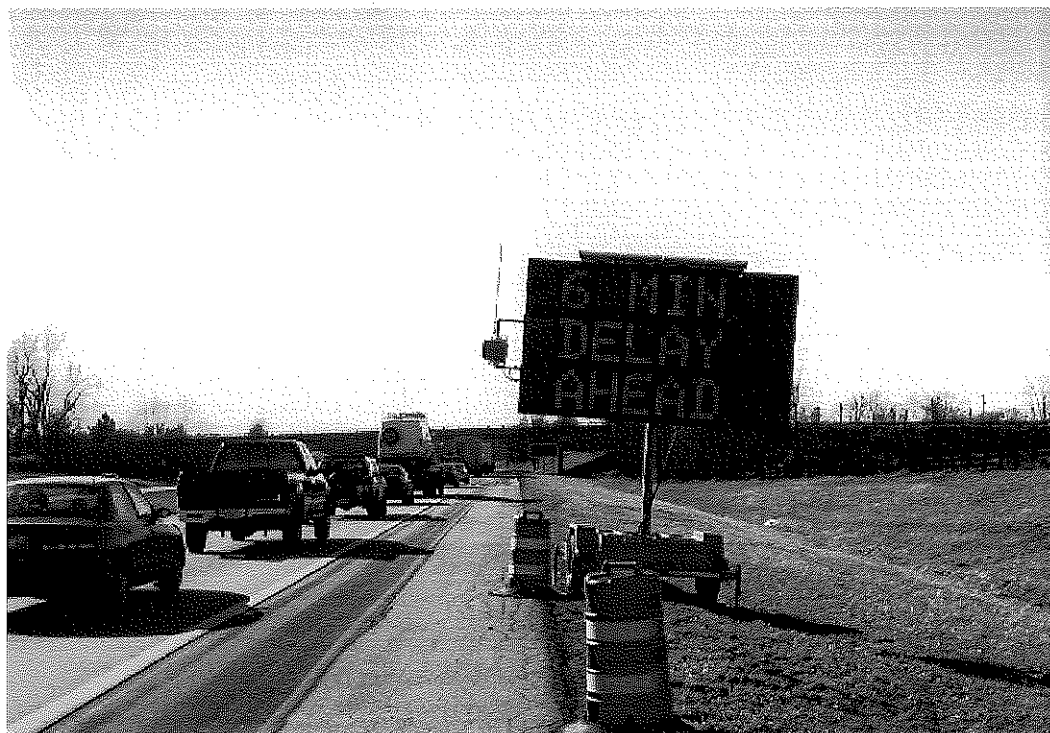
Figure 4. Delay Message.

The delay from a specific VMS to the end of the work zone was calculated by comparing the time necessary to travel from that VMS at the posted speed limits compared to the time required to travel through the work zone at the speeds measured by the radar units. The speed limits used were 65 mph in advance of the lane closure and 55 mph through the lane closure and extending approximately to the first VMS. Slightly different methods were used by the two systems to determine speeds between signs. Either the speed determined at a specific sign was used as the speed to the next downstream sign or the average speeds between two adjacent signs were used as the speed between those signs. The speed at the arrow display was used as the speed through the lane closure portion of the work zone. A minimum speed was used through the work area (after the start of the lane closure) since no radar units were placed in this area. A minimum speed of 10 mph was used by ADAPTIR. The length of the work area (lane closure) varied slightly depending on where the work was being conducted. In any case, the work zone was a few miles in length and the speed at the arrow display (with the specified minimum) was used over this length. A delay message was displayed when the delay through the work zone reached a threshold of five minutes. The delay message consisted of a sequence of the following two messages. A photograph showing a delay message is shown in Figure 4.

ROADWAY		X MIN
ADVISORY		DELAY
XX AM OR PM	followed by	AHEAD

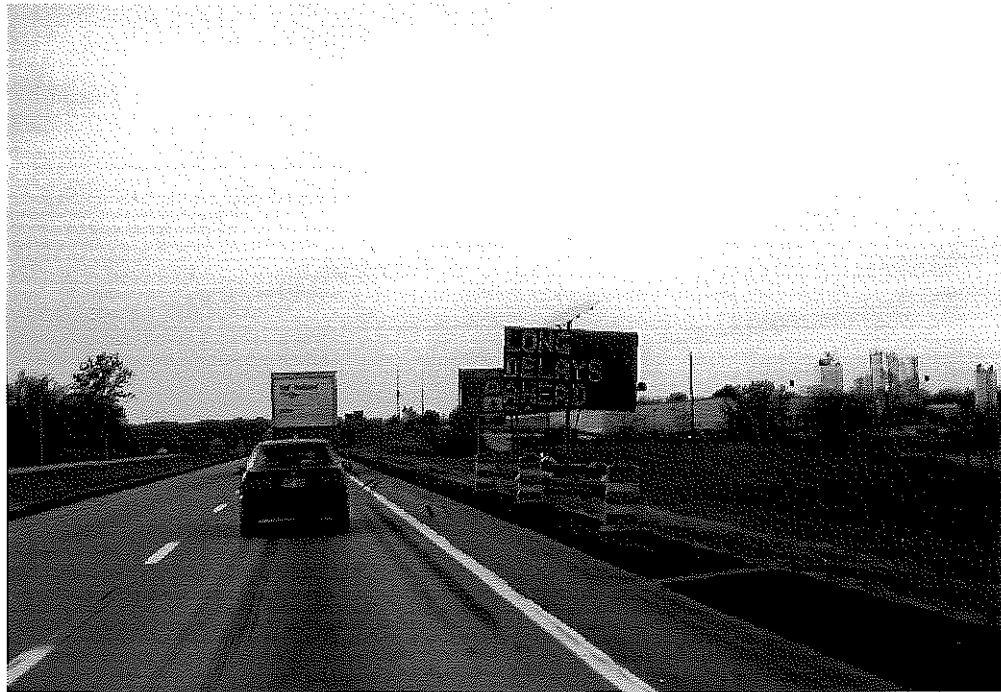
Figure 5. Long Delay Message.

The final message related to an alternate route. It was displayed when the delay reached 15 minutes and this delay was maintained for a minimum time of 10 minutes for the ADAPTIR system and 9 minutes for the contractor's system. The diversion message consisted of a sequence of the following two messages (Figures 5 and 6).

LONG		ALT RTE
DELAYS		FOLLOW
AHEAD	followed by	EXIT XX

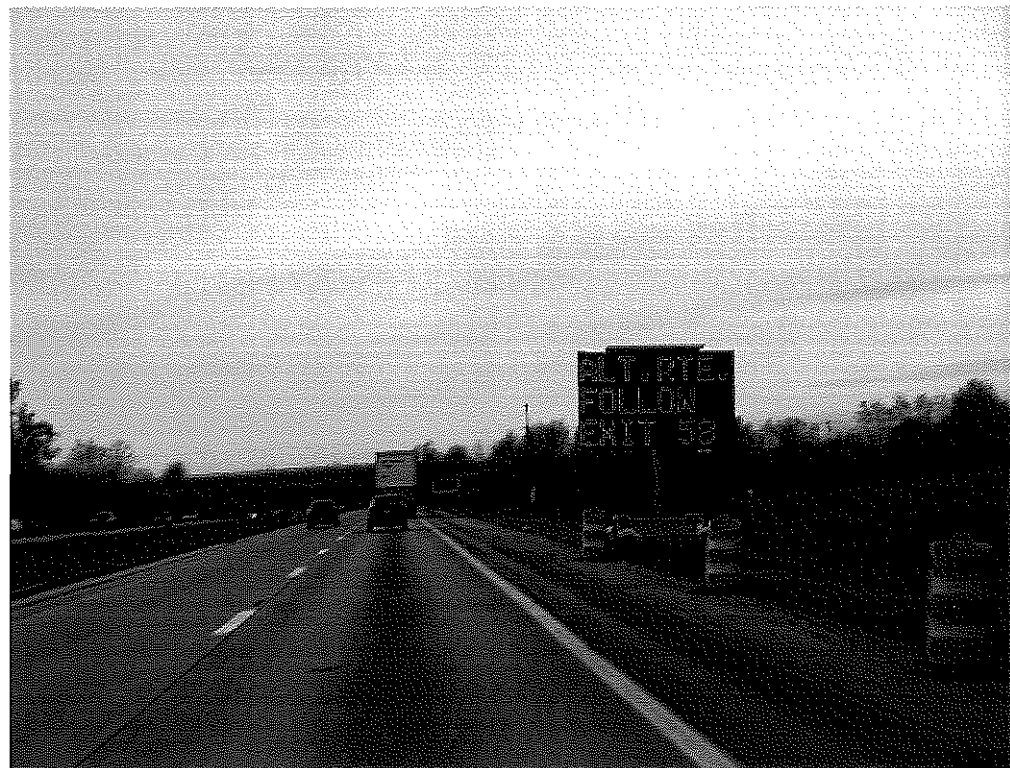
Figure 6. Alternate Route Message.

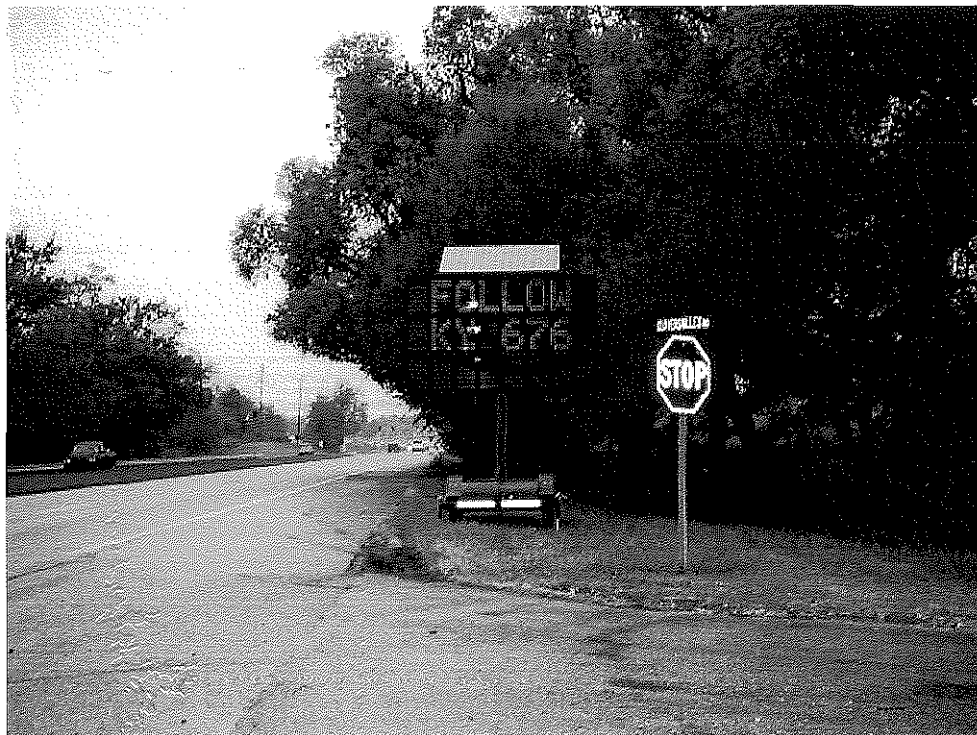
Figure 8. Message on Intersecting Route Advising Use of Alternate Route.

This system provided information to motorists on the interstate. Additional VMS were placed on the diversion route to provide information when excessive delays occurred (Figures 7 and 8). The messages on these signs were input manually.
